St Paul's
Cathedral: 300th
anniversary
restoration

Restored interior is latest phase to be unveiled after four years under wraps

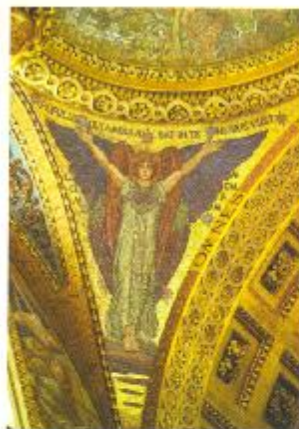
One of the magnificent mosaics after restoration. Photo: Sampson Lloyd

were installed at the end of the 19th century but accumulated dirt had obscured their magnificence. They were meticulously cleaned by hand, using cotton-wool buds and de-ionised water. The St Mark's pendentive mosaic in the north east corner was found to be detached from its backing, partly due to inadequate setting of the mortar and partly due to the vibrations of the adjacent organ. This was carefully removed from the backing, old mortar cleaned off and then re-applied to a new backing.

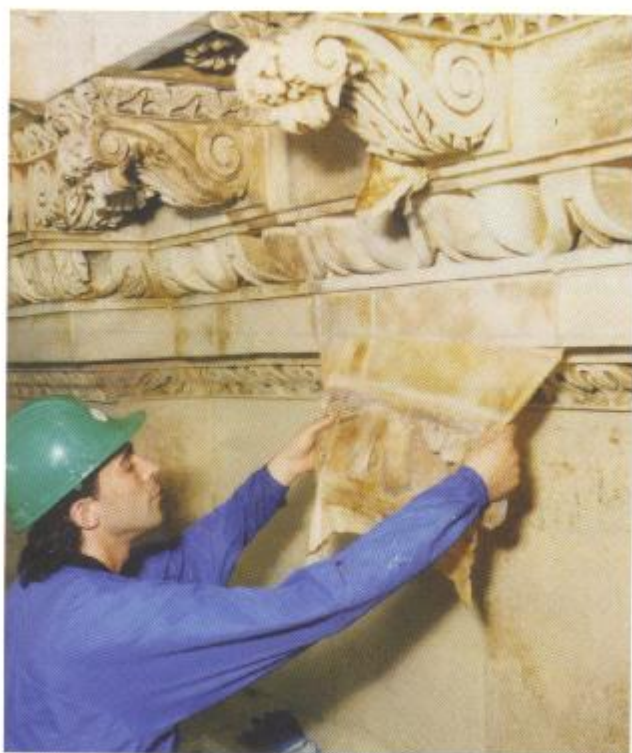
The interior stonework has been cleaned using Arte Mundit – a latex-based compound. Picture© construction photography

Wren designed his cathedral to be light and airy, but the London smog meant that the internal stone had become heavily dirtied over the centuries. The original painted finish was stripped off in the 1870s, and attempts to clean the interior again in the 1930s were largely unsuccessful. The interior stonework has now been cleaned using Arte Mundit – a latex-based

compound that acts like a facemask, drawing dirt and impurities out of the stone before being gently peeled off. One panel of stone next to the great west doors has been left uncleaned to allow visitors to see the amazing transformation that has taken place.

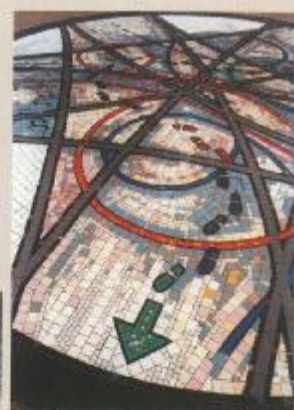
Mosaic conservation/restoration at St. Paul's Cathedral, London
